MOUNT ZIRCON RESERVOIR DAM  
ME-00244

PHASE I INSPECTION REPORT  
NATIONAL DAM INSPECTION PROGRAM

DEPARTMENT OF THE ARMY  
NEW ENGLAND DIVISION, CORPS OF ENGINEERS  
WALTHAM, MASS. 02154

OCTOBER 1978

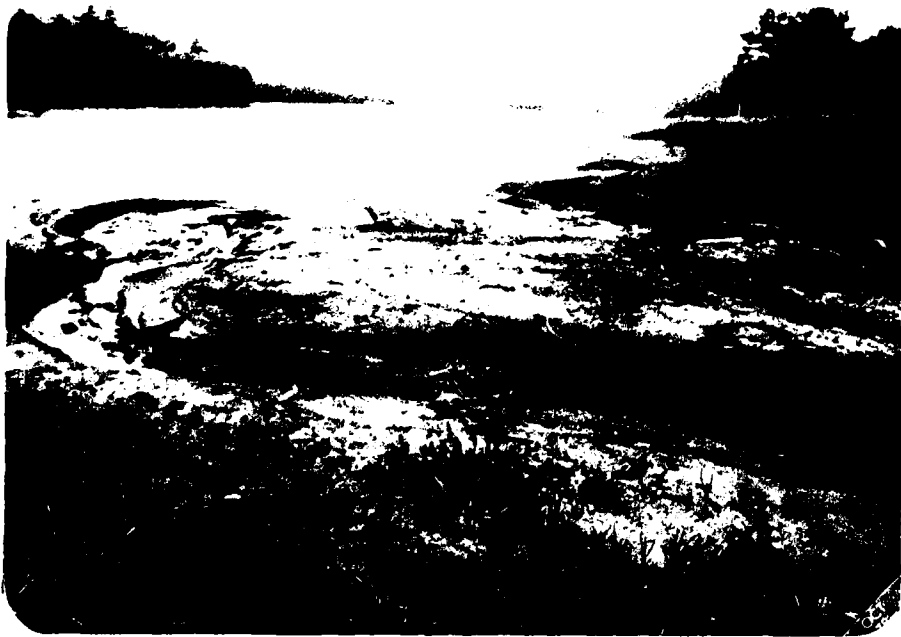
7

- a. Shore Line. No major active or inactive landslide areas on Mount Zircon Reservoir were observed.
- b. Sedimentation. The watershed has remained essentially rural. There are no new developments or new sources of sediment loads on the reservoir. However, sediment at least 2 feet in depth covers the southerly shore of the reservoir at the inlet end, as shown in Photograph 7.

SILT DEPOSITS AT INLET TO RESERVOIR

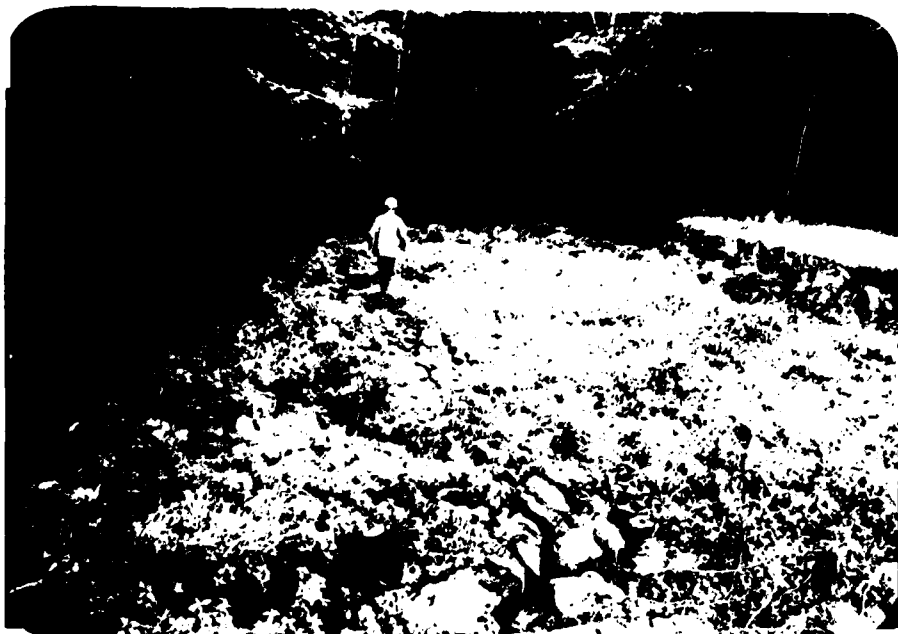
3

- d. Stilling Basin. No provision for preventing erosion was noted below the 24-inch outlet. Rip rap is shown on the drawings but none was observed.
- e. Approach and Outlet Channels. The approach is not visible due to water levels. The outlet channel is lined with brush and small trees, as shown in Photograph 3.

- a. Control Gates. None.
- b. Unlined Saddle Spillways. None.
- c. Approach and Outlet Channels. The approach channel is flat and slopes gently toward the pond. It is clear and unobstructed. The outlet channel has a moderate slope (5-10 percent) and low small brush lines the channel. A large tree has fallen into the channel downstream of the spillway. See Photographs 3, 4 and 6.
- d. Stilling Basin. Below the spillway crest is a channel paved with stone which is in good condition. One small cavity was observed. See Photograph 3.

SPILLWAY DISCHARGE CHANNEL

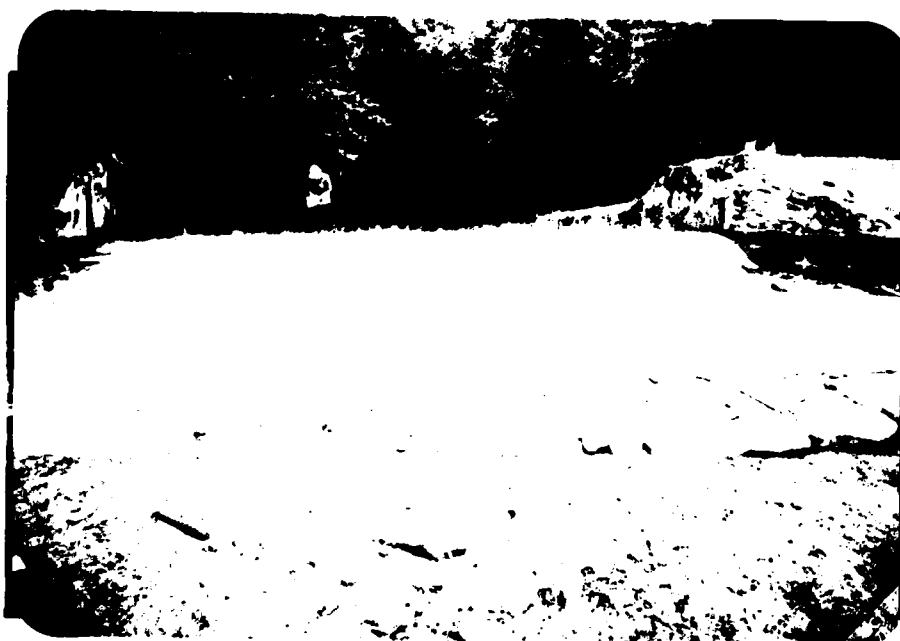
4

Stone Masonry Surfaces. The surface of the stone masonry in the spillway is in good condition. The masonry has been repointed and the condition of the mortar is generally good.

- b. Structural Cracking. No cracking of the concrete gate house was noted. Some cracking of the mortar joints in the spillway was observed.

SPILLWAY

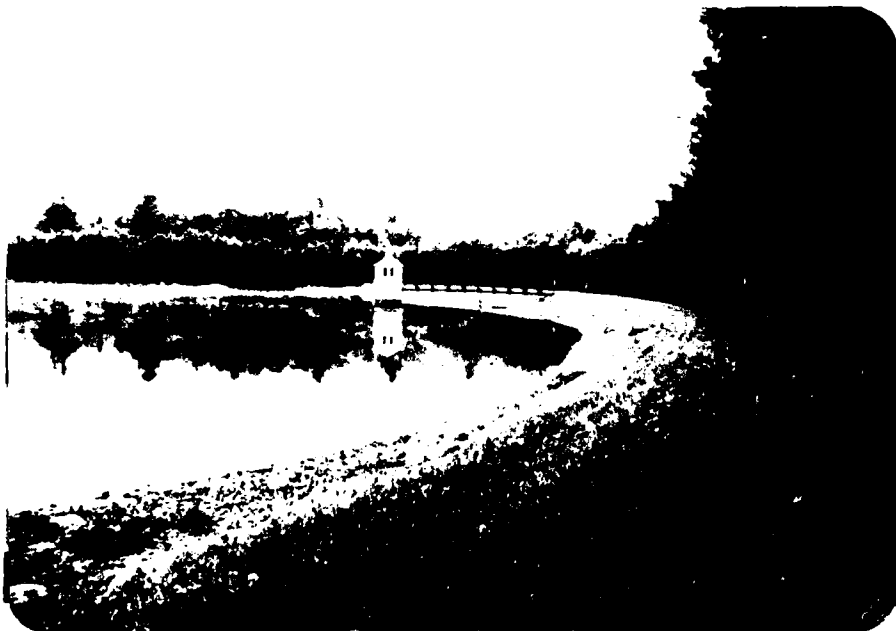
1

VIEW OF DAM FROM EAST END

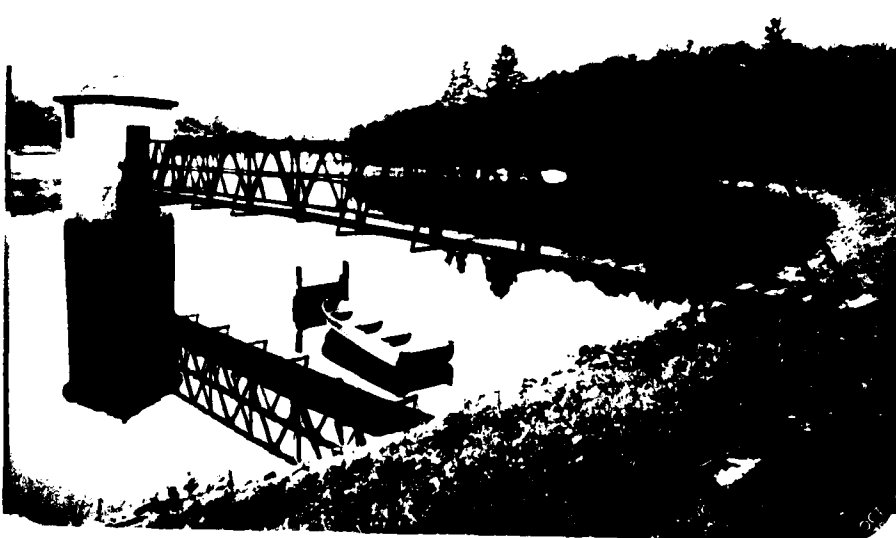
2

c. Appurtenant Structures. The gate house is an appurtenant structure to the dam. It is constructed of reinforced concrete. Some spalling of the concrete has occurred near the water level. Generally the structure is in good condition. The service bridge to the gate house appears to be in good condition structurally but the deck planking is rotted.

- a. Concrete Surfaces. Except for the zone from about elevation 835 to 840 the concrete surface of the gate house is good. Within the zone from elevation 835 to 840, the exterior surface is spalled to a depth of 1 to 3 inches. The area has been previously repaired and since spalled again.

CONTROL GATE HOUSE

5. The spalled concrete on the sidewalls of the gate works should be repaired.
6. The condition of the riprap slope protection should be examined at least once each year and whenever the reservoir level is low enough to permit direct observation. Repairs should be scheduled if conditions warrant.
